# Clogged Leachate System Rehabilitation

Joseph Nemesh, P.E. - Senior Project Manager

Cornerstone Environmental Group, LLC – A Tetra Tech Company

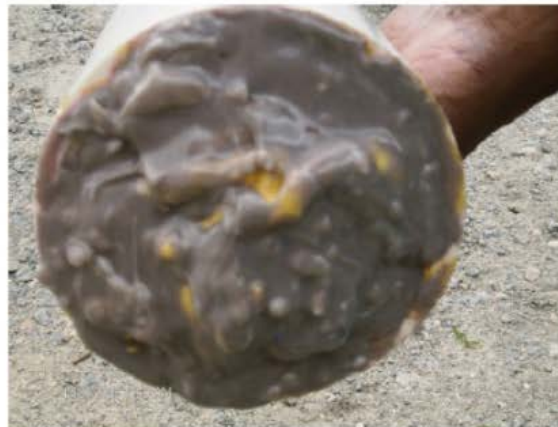
Before

- High-pressure water jetting

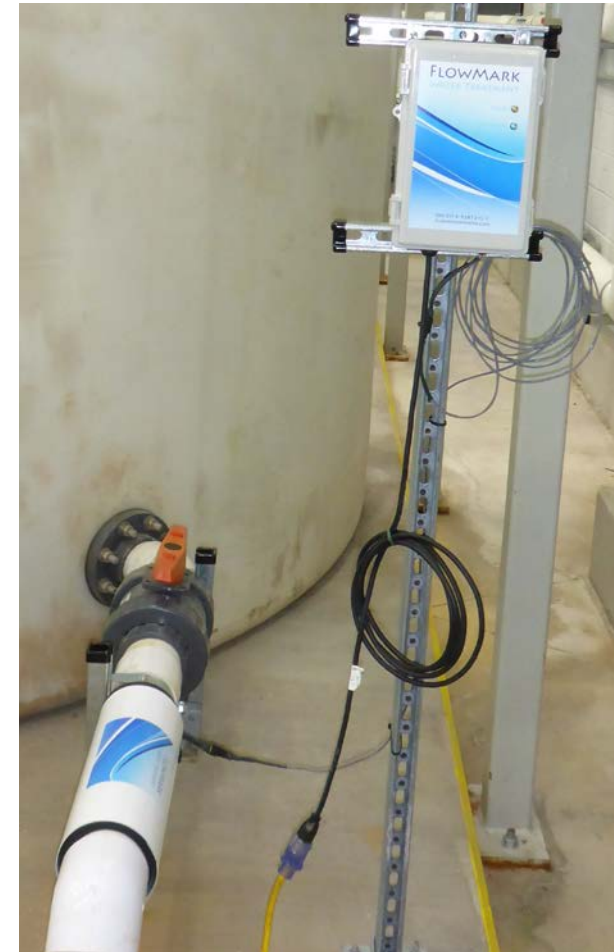
- Electronic descaling systems

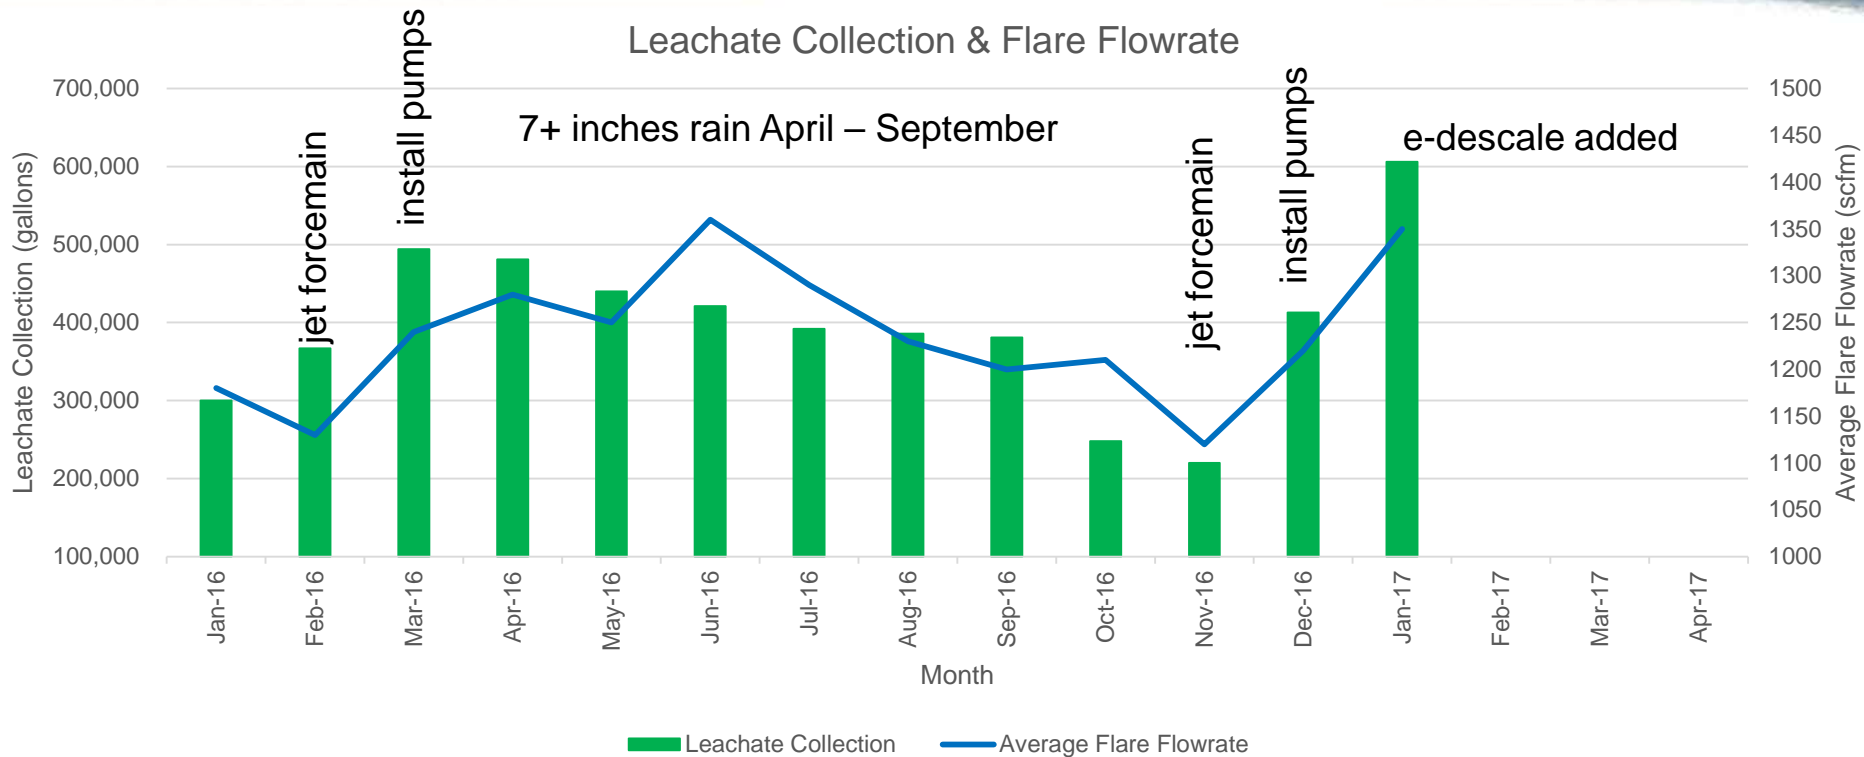
# Combined Leachate & Flare Data

- Drop in leachate generation
- Drop in flare flow
- Wet summer weather
- Leachate seeps popping up
- Odors

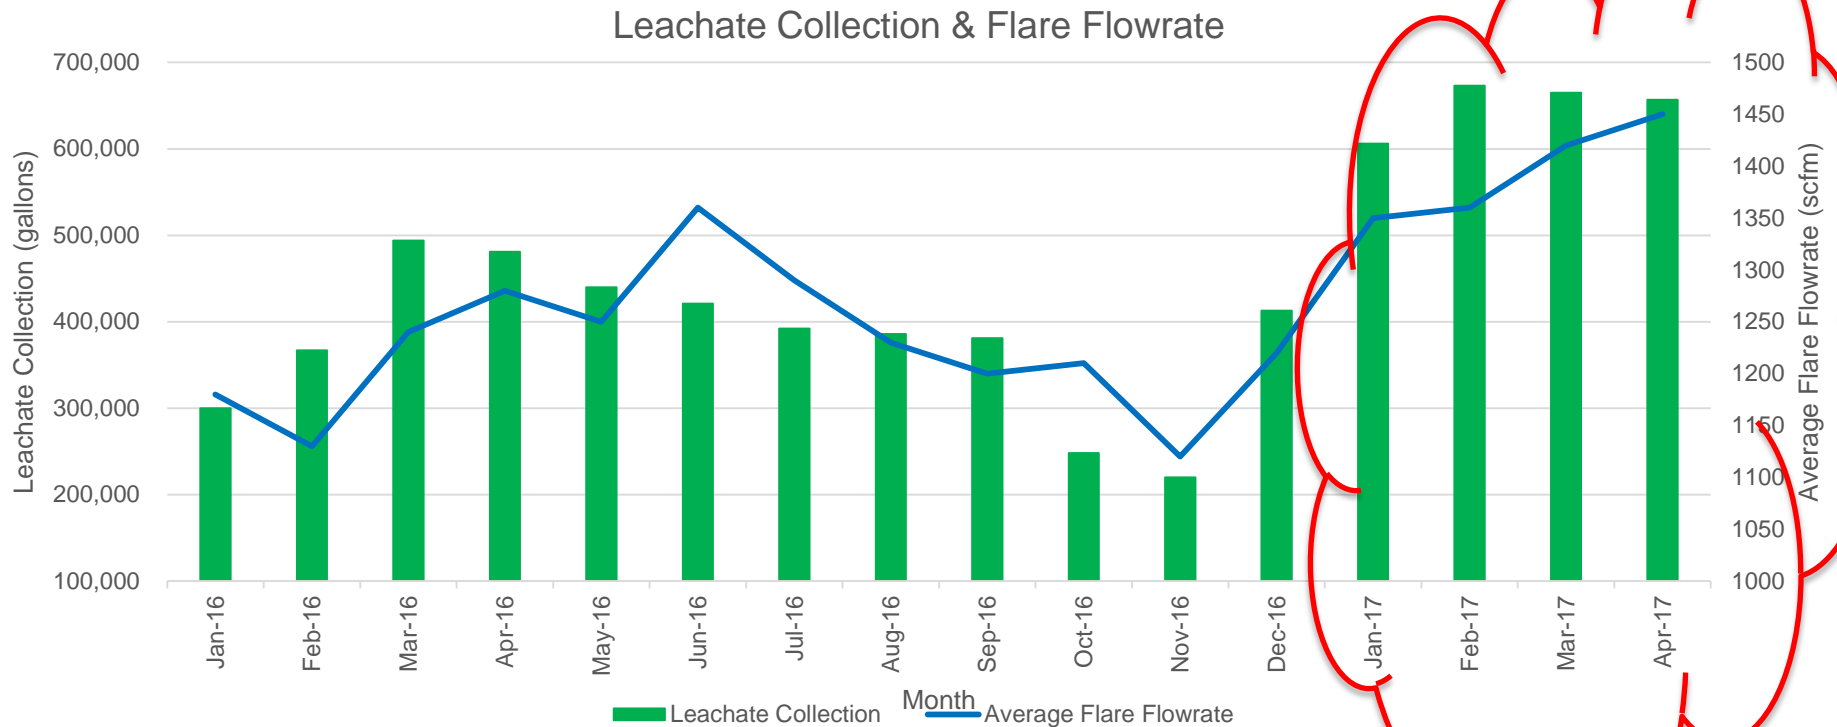
# Combined Leachate and Flare Data

- Electronic descaling unit seems to be working
- Very wet weather
- Mild winter temperatures
- Another electronic descaling unit installed in late April
